CONCRETE STRUCTURES

ANNUAL TECHNICAL JOURNAL

2000

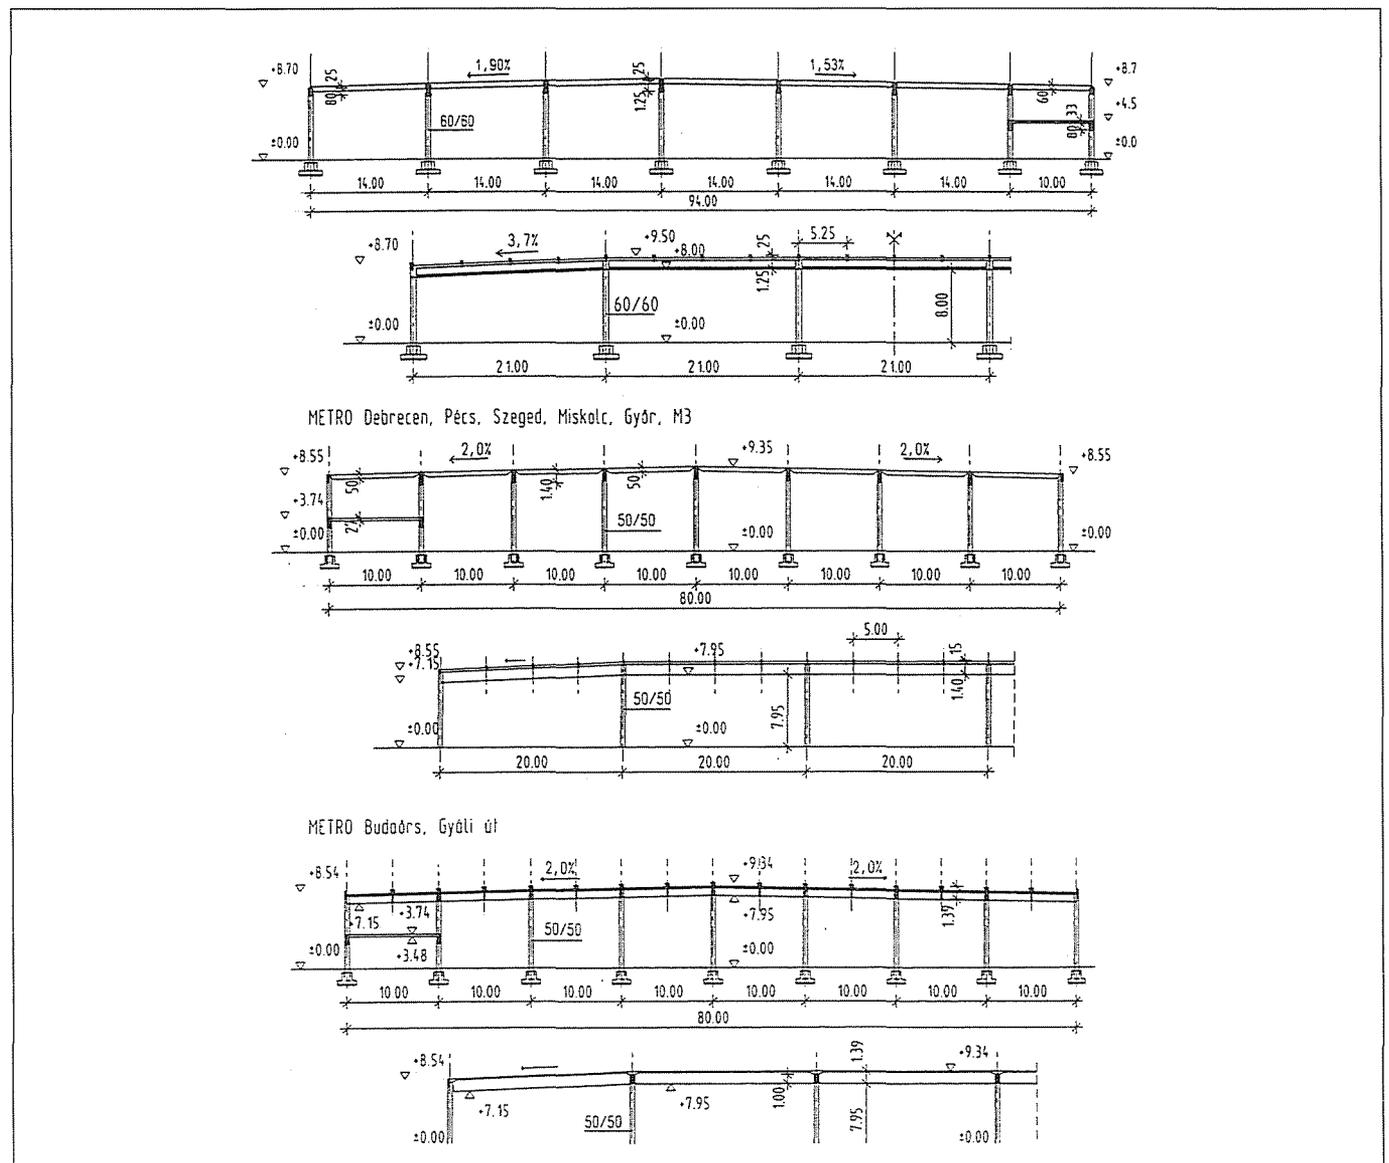
Fig. 1 METRO department stores in Hungary and Romania, 1994–1999

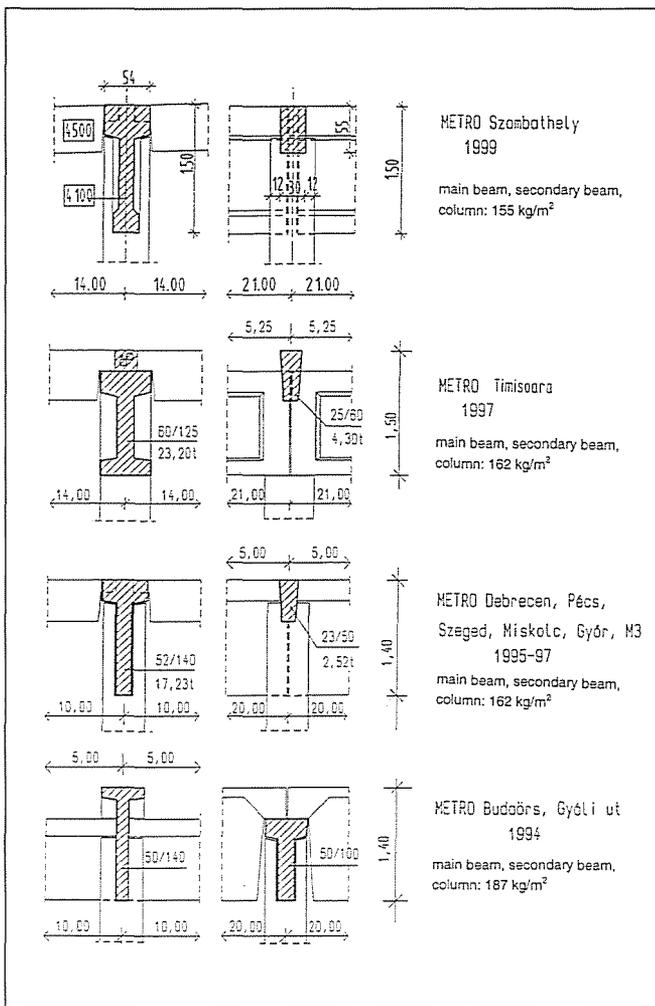
Fig. 2 Details of METRO department stores in Hungary and Romania, 1994-1999

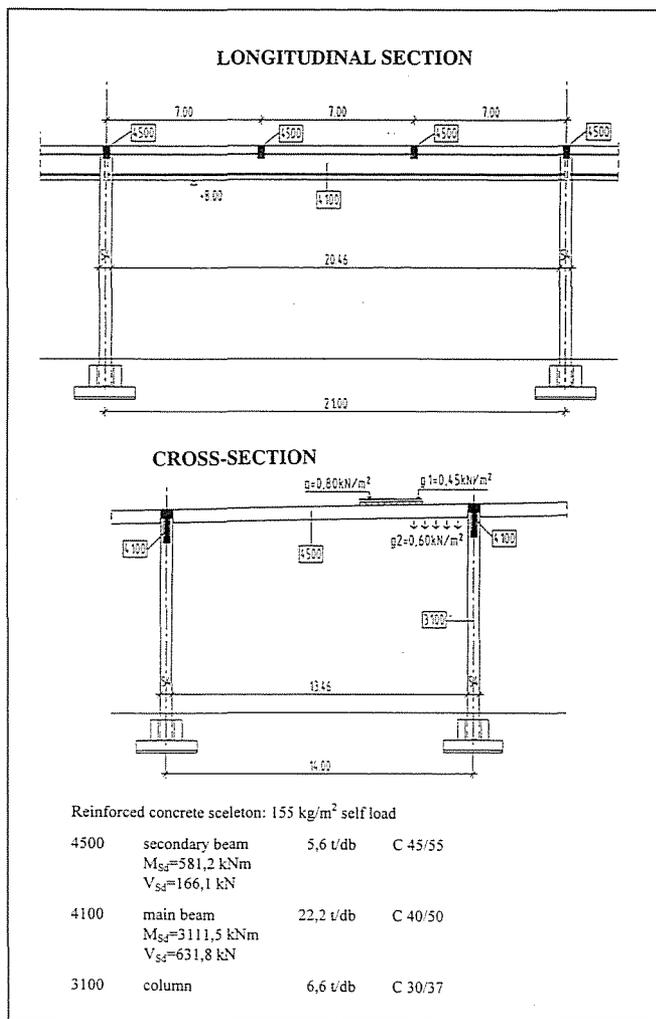
Fig. 4 METRO department store in Hungary, 1999 (as planned)

References to the individual elements of the structure are extremely important in the case of a “distant design project”. Therefore, all the design sheets, element signs, stresses, location codes and quality certificates use the same codes no matter how they are transmitted from one country to another – by wire, by car or by rail (Figs. 4 and 5).

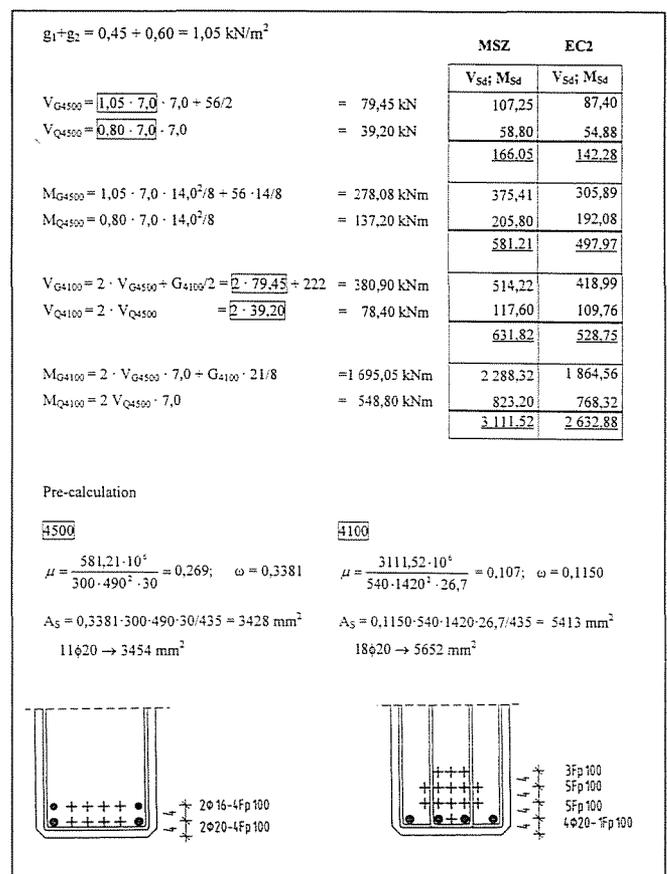
Fig. 5 METRO department store in Hungary, 1999, calculation No. 1.

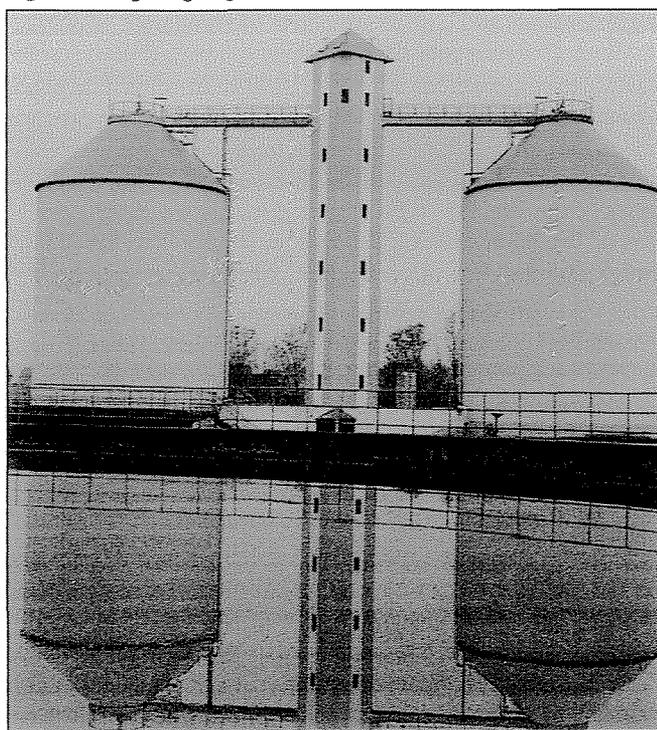
Fig. 1 Working sludge digesters

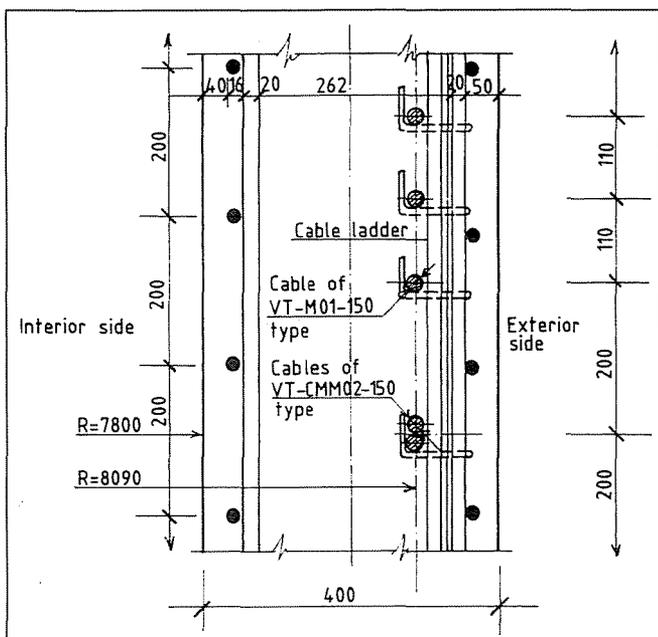
Fig. 4 Reinforcement of cylindrical wall, detail

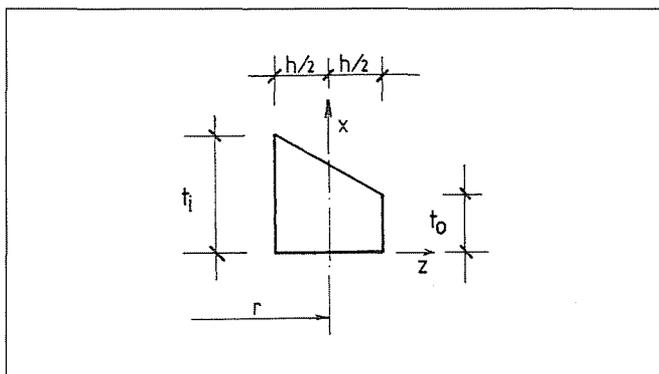
Fig. 1 Distribution of temperature variation over the wall thickness

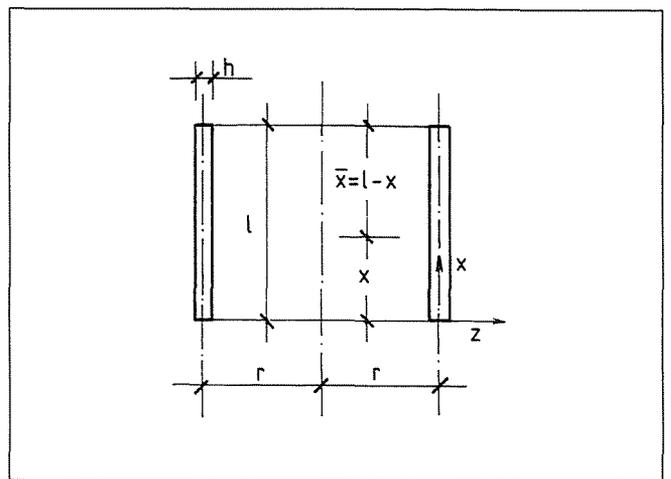
Fig. 2 Geometrical data and coordinate system of analysis

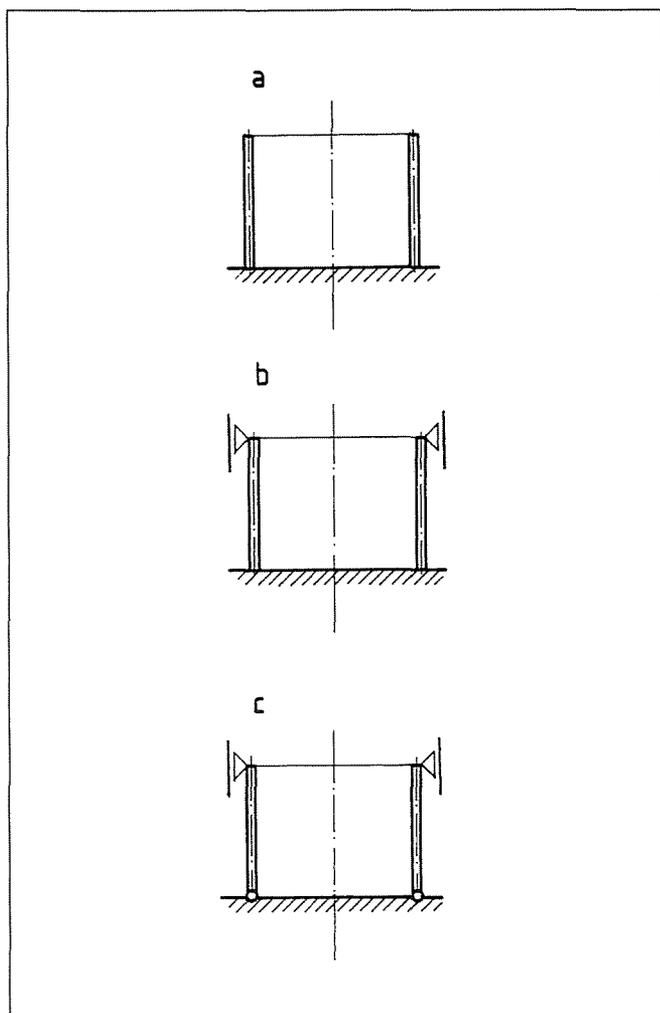
Fig. 3 Typical combinations of edge supports of the wall

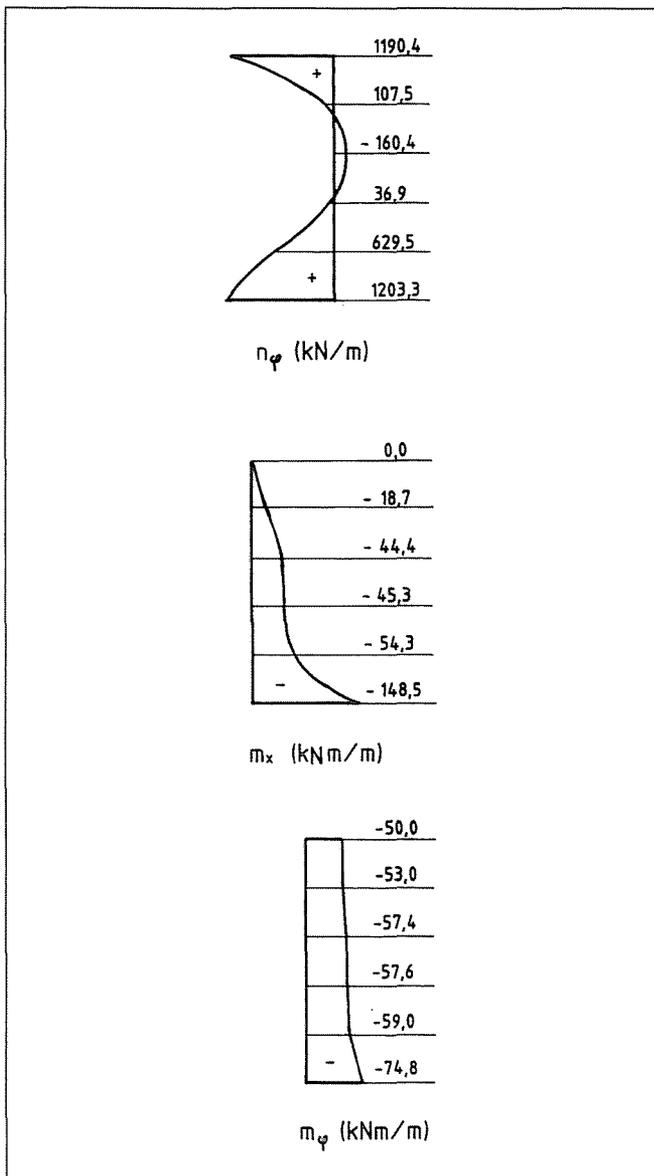
Fig. 4 Internal forces of a circular tank fixed at the bottom, hinged at the top ($t_i = 0^\circ\text{C}$, $t_o = -30^\circ\text{C}$)

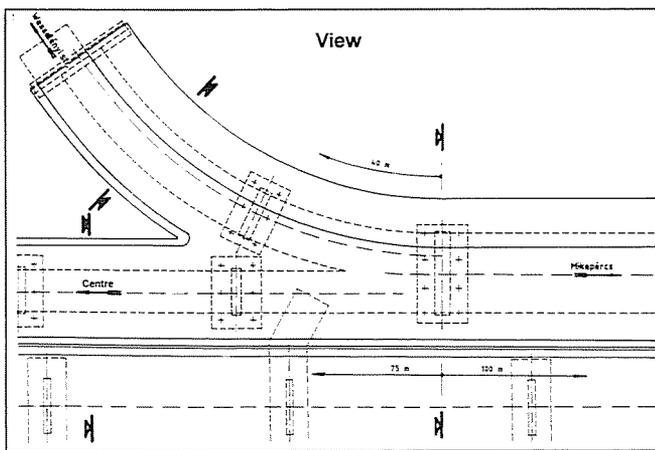
Fig. 1 Layout of the bridge at the access branch

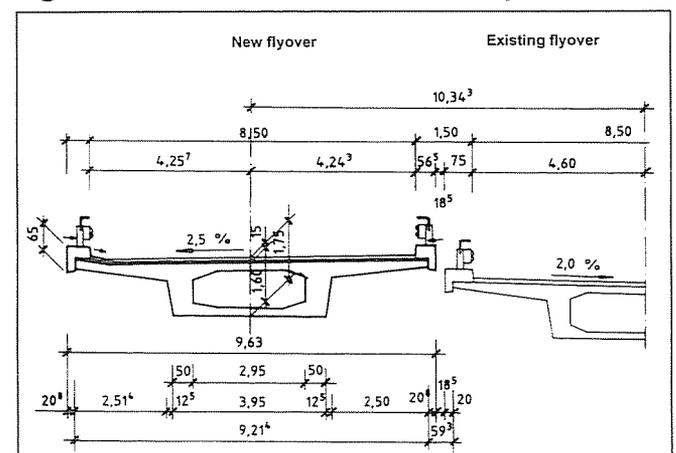
Fig. 4 Transverse section shown from the city

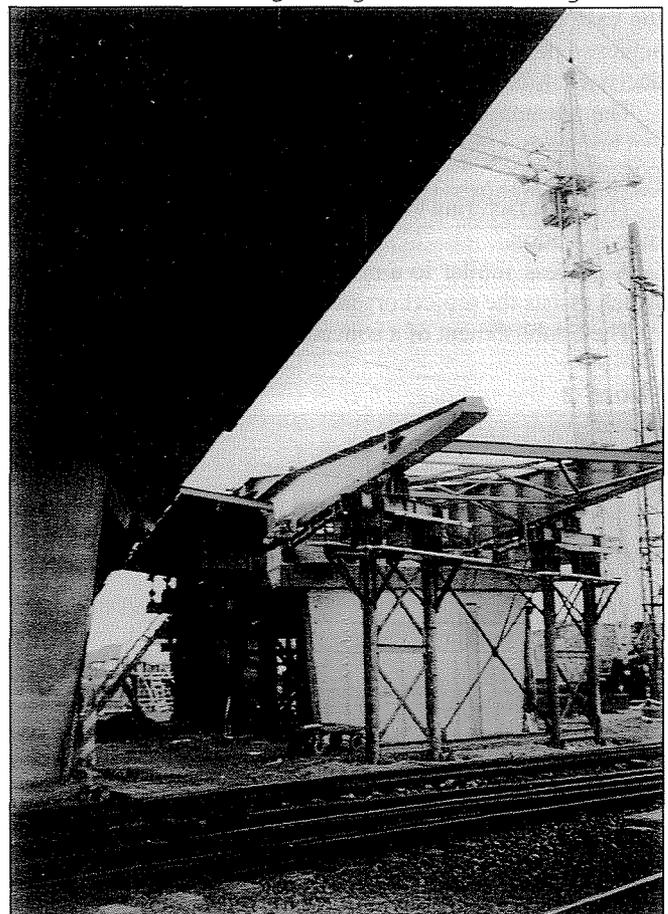
Photo 1 Manufacturing stalling and steel launching nose

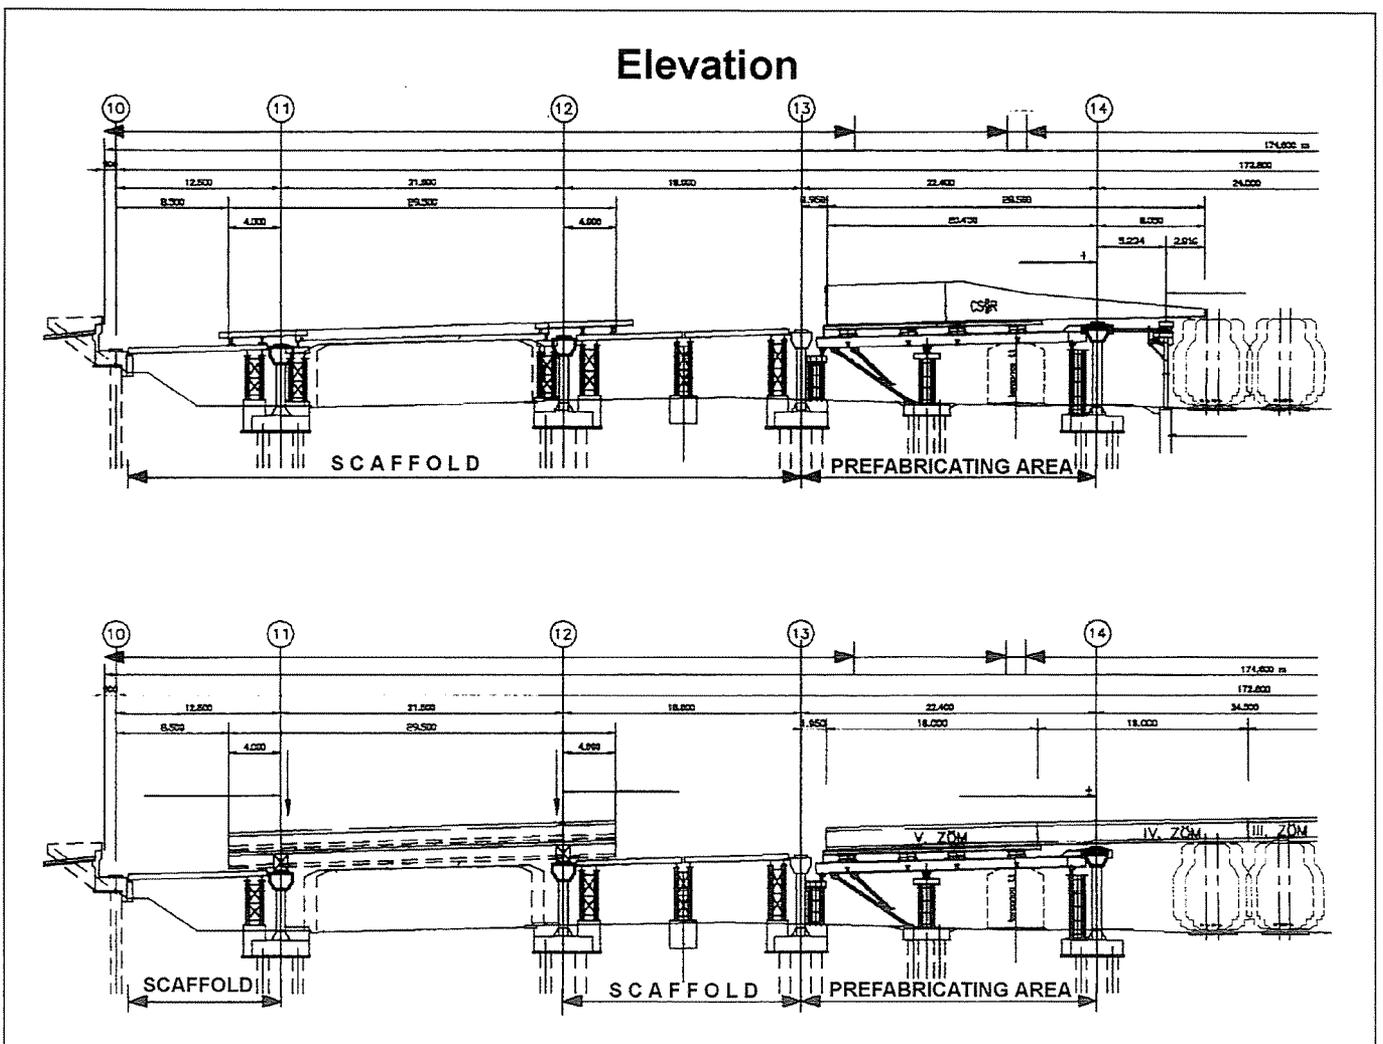
Fig. 5 Structure built on scaffold and the beginning of incremental launching

cause disruptions to traffic flow affect all parties and thus becomes costly for both the railway company and contractor (Figs.5 and 6).

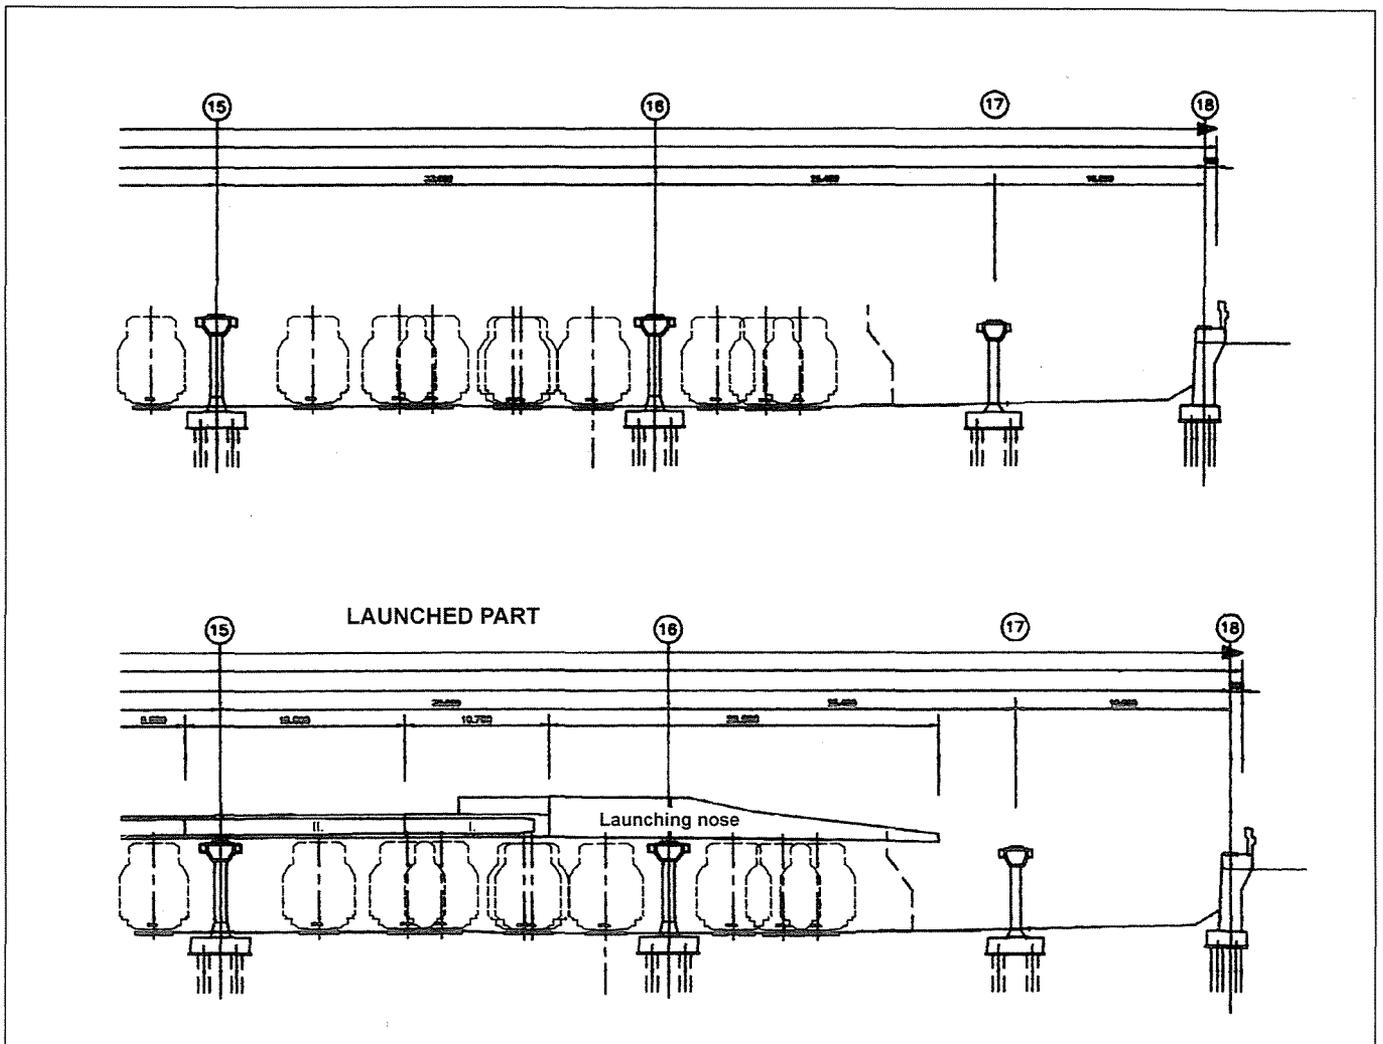
Fig. 6 Construction phases over the railway

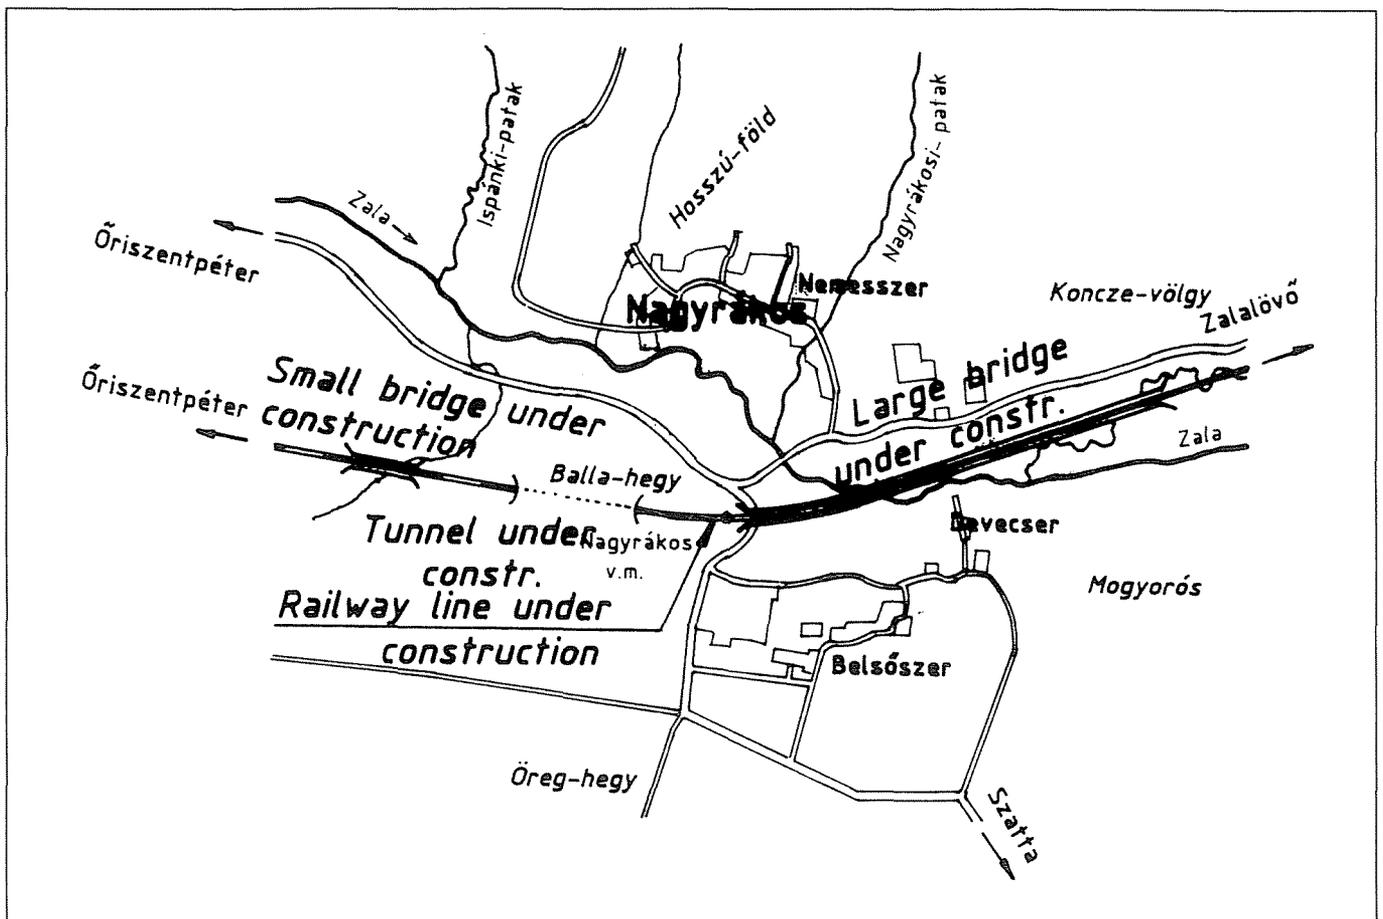
Fig. 1 Site plan of the railway line under construction

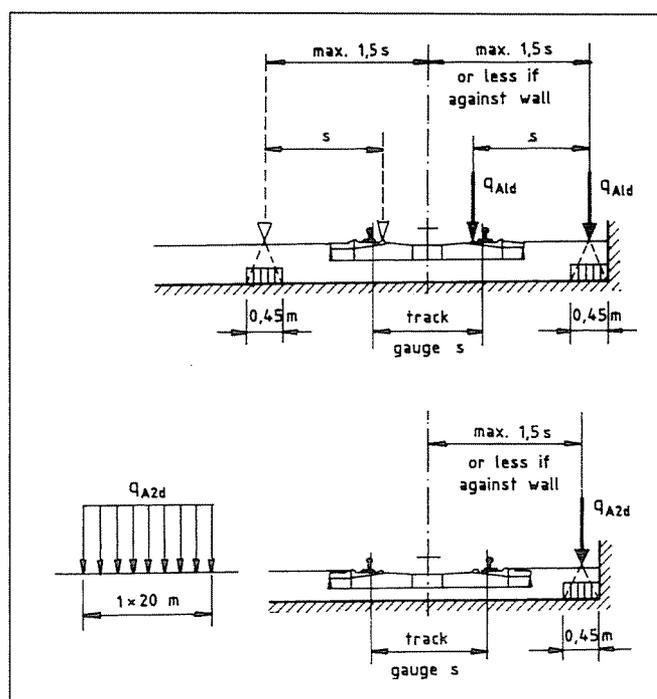
Fig. 3 Examination the effect of a derailed vehicle by EUROCODE

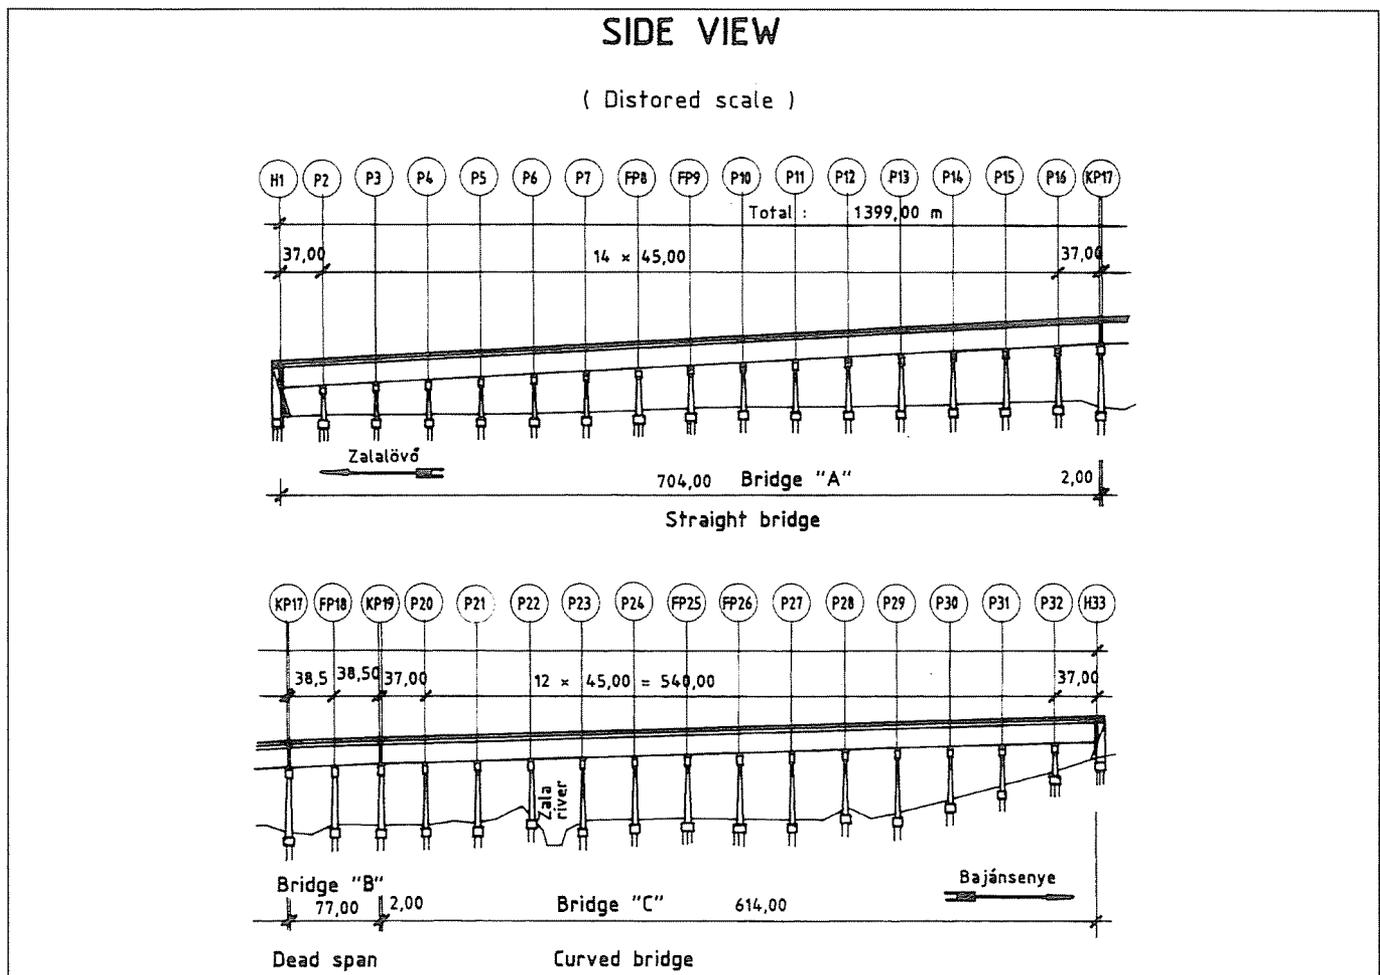
Fig. 4 Elevation of the viaduct being built

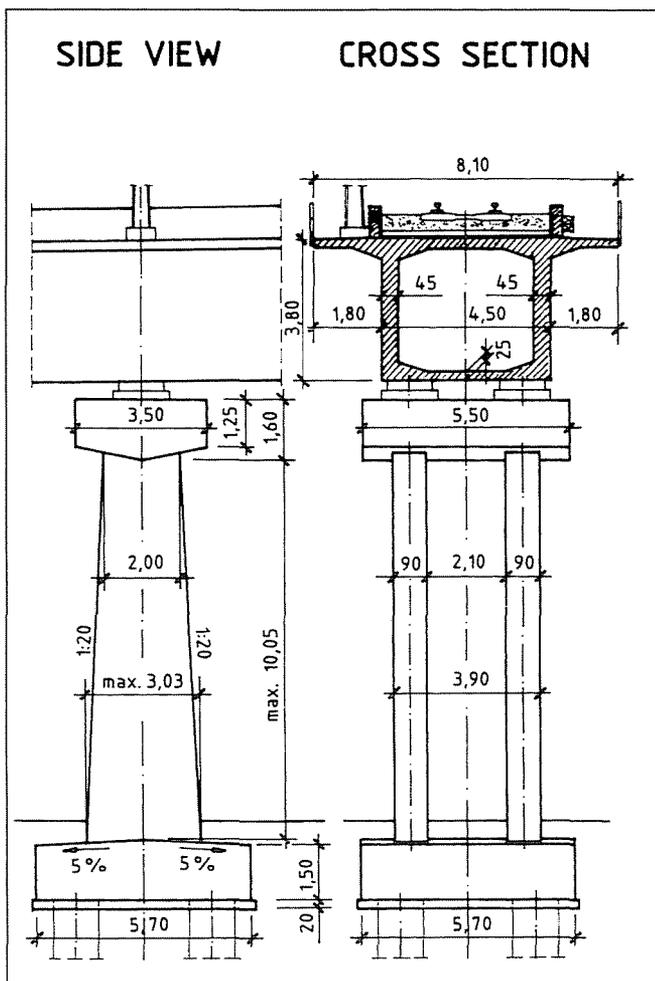
Fig. 5 Structural elements of the viaduct, being built

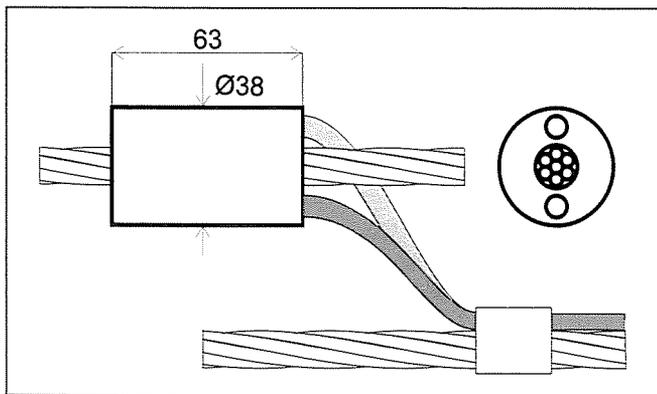
Fig. 1 Sensors pulled onto tendons built-in UBx type prefabricated, prestressed concrete beams

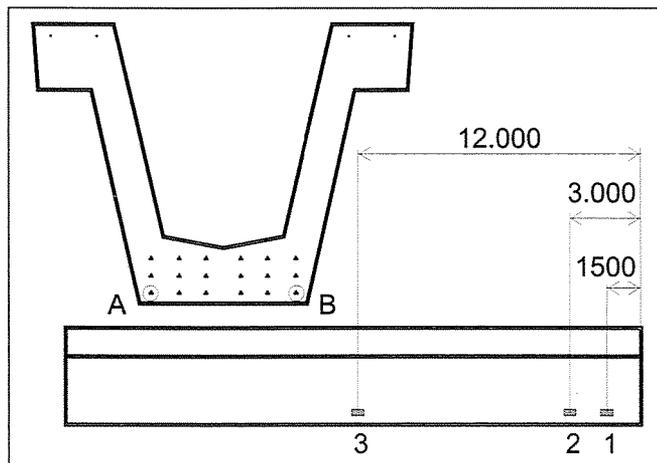
Fig. 2 Arrangement of tendons in an UBx type prestressed concrete beam and the location of sensors

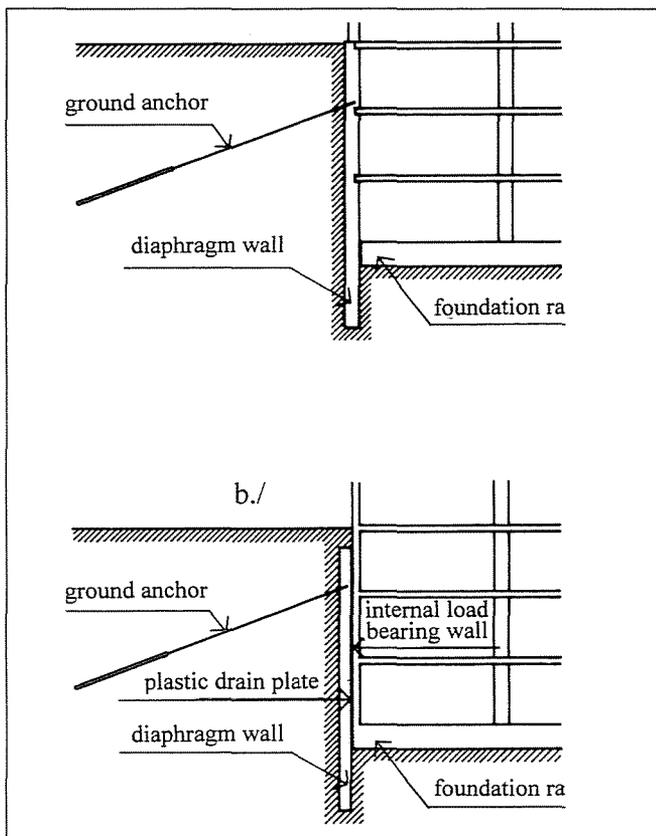
Fig. 1 Connection of diaphragm wall and basement floor slabs.
a) Floor slab edges of the basement supported by the wall.
b) The diaphragm wall acting as an external wall to support ground pressure; floor slabs are supported by a separate wall.

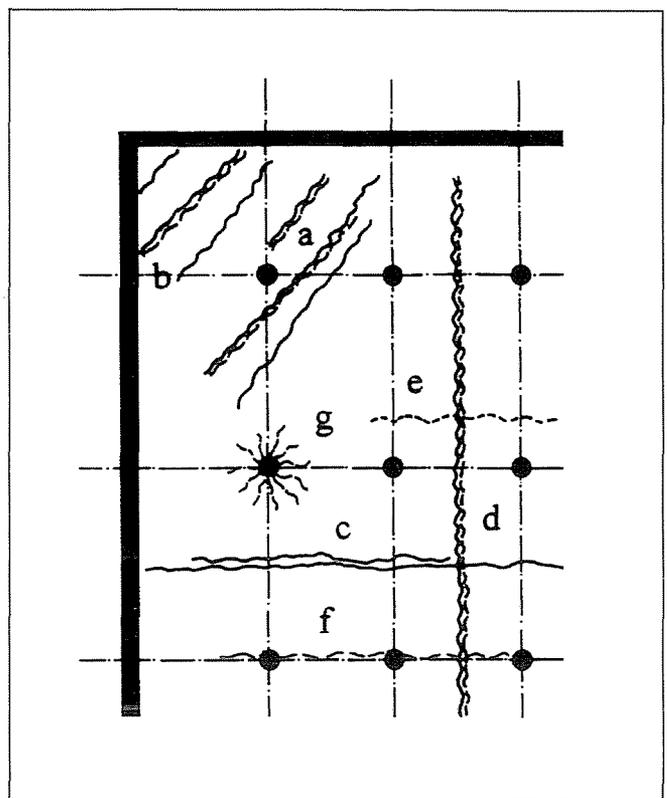
Fig. 2 Typical floor slabs cracks:
(a) a through-crack at an angle of approx. 45° at the joint of diaphragm walls.
(b) a crack on the bottom surface of the floor slab at an angle of approx. 45° at the joint of diaphragm walls.
(c) cracks on the bottom surface of the floor slab at the location of the maximum positive moment.
(d) through cracks at the mid-span.
(e) a crack on the top surface of the floor slab around the line where the moment is zero.
(f) a crack on the top surface of the floor slab at the line where the negative moment is zero.
(g) radial cracks on the top surface of the floor slab around the columns.

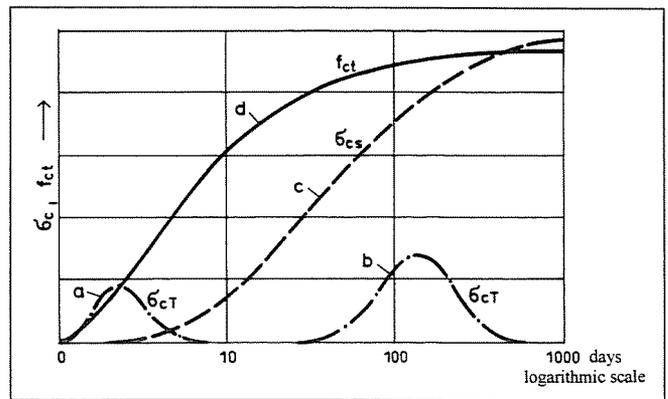
Fig. 3 Evolution of tensile stresses and tensile strength in the concrete.

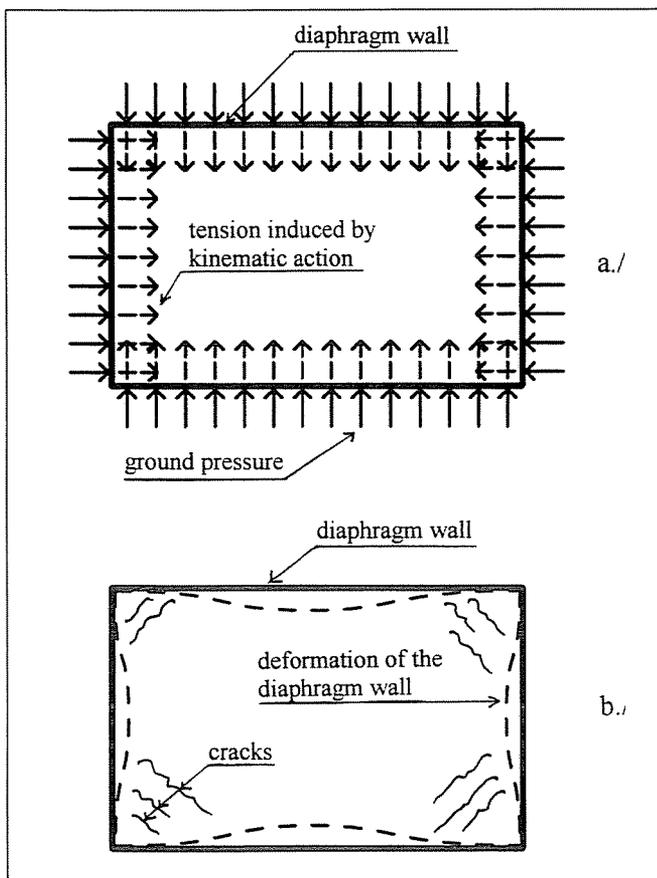
Fig. 5 Deformation of diaphragm wall
 (a) horizontal loads acting on the diaphragm wall
 (b) deformation and cracks of the diaphragm wall

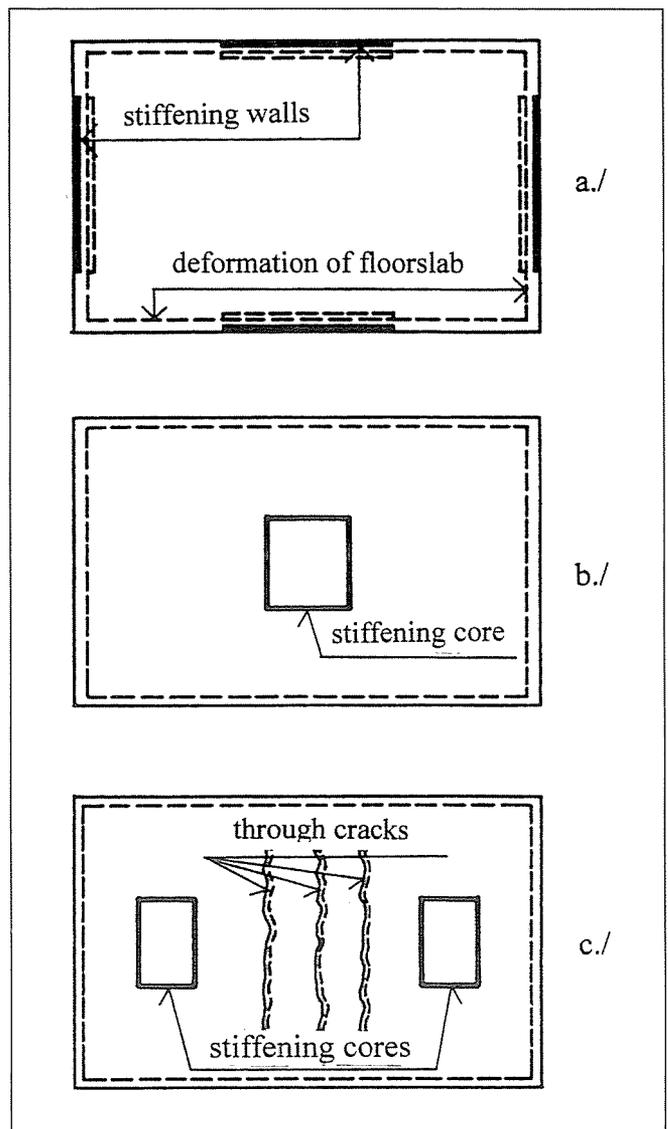
Fig. 6 Effect of the arrangement of stiffening structures:
 a) favourable
 b) favourable
 c) unfavourable arrangement

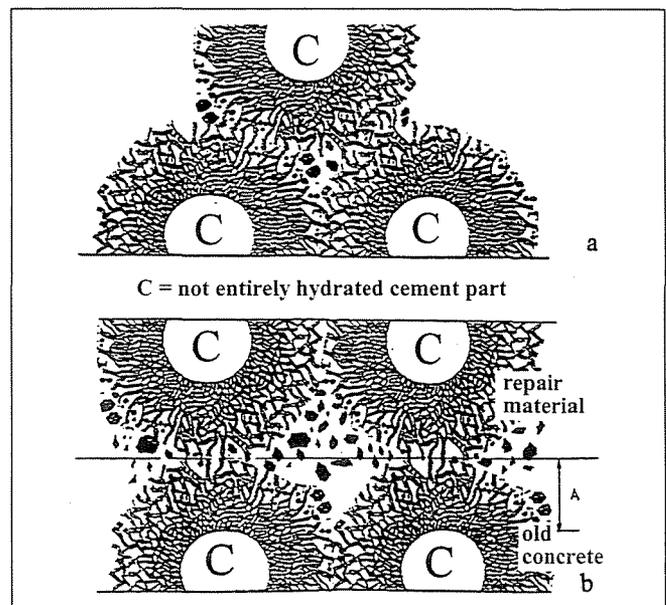
Fig. 2 Sketch of the joint of a silicate frame, a) in a state when they are not completely grown together, b) their principal scheme

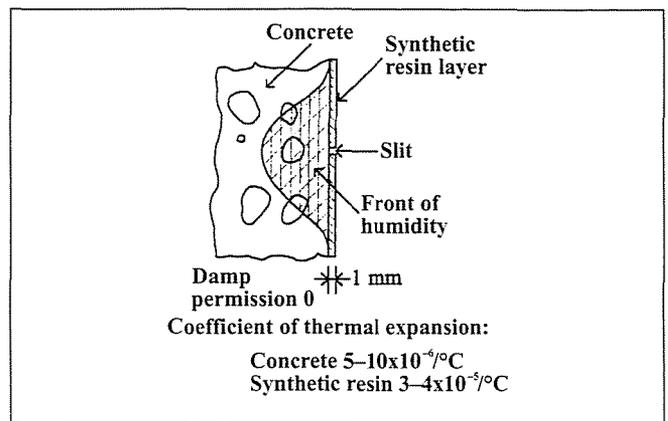
Fig. 4 The water front spreads below the damaged resin layer, it can not dry out

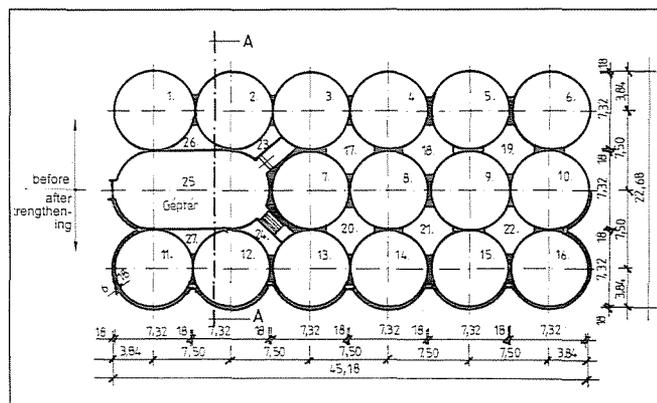
Fig. 2 Vertical section of the silo

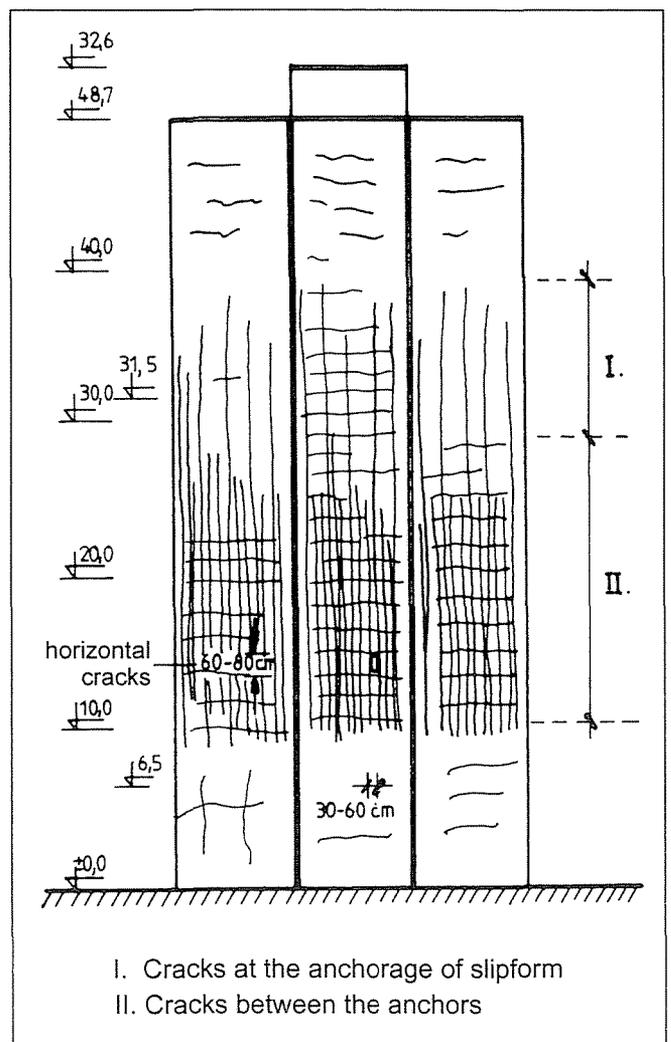
Fig. 3 Characteristic cracks in the silo walls

During the construction in 1975, significant faults resulted which were mostly due to the non-adherence to the specifications relating to the use of the slipform technology. These can be summarised as follows:

The advisory paper prepared at the Technical University of Budapest in 1975 indicated that due to the deficiencies observed during the construction, vertical cracks were likely to result. This prediction was borne out in subsequent years. The periodic inspection records of the silo document the slow deterioration of the structure. The Elasztolen surface protection layer applied to the outer walls did not meet the expectations and the material was unable to bridge or cover the cracks that appeared. Rain was able to penetrate through the cracks and damage the stored grain. In order to reduce the additional pressure that occurs when the stored material is evacuated, a method of removing the grain through the intermediary cells was originally planned. This method was utilised since measurements taken at Hódmezővásárhely conclusively proved that emptying the silo through the intermediary cells resulted only in the usual pressure due to storage. There was no additional pressure caused by the emptying of the stored material (Orosz and Simurda, 1985). However, there was a departure from the original plan and a pipe system attached to the outer silo walls was constructed. These pipes attempted to simulate the method of emptying the silo through the intermediary cells. Measurements of crack width were subsequently taken in 1987 by the Technical University of Budapest to evaluate the effectiveness of these emptying pipes. The measurements verified that a 50% reduction in pressure could be achieved compared to emptying the silo through four openings. The effectiveness in reducing pressure falls short, however, compared to when the silo is emptied through the intermediate cells (Orosz and Simurda, 1986). As time went by the condition of the emptying pipes deteriorated and the silo fell into disrepair. The danger caused by inadequate reinforcement and subsequent corrosion resulted in the curtailment of the silo's operation. Limited operation was mandated in the 1993 inspection report which was accompanied by recommendations either to reinforce the silo by applying shotcrete externally or by constructing an internal coat by slip-forming or the application of shotcrete (Herkó, 1993). The repetitive damage to the grain due to water seepage and the operational limits placed on the silo added urgency to completing the renovation and an additional inspection was performed in 1997 (Zsoldos, Csathó). Core sampling and 'Schmidt' hammer examination of the concrete confirmed that the strength of the concrete was adequate and that the reinforcement did not show signs of extensive corrosion. Therefore, corrosion did not have to be taken into account in the structural calculations. The recommendations included unloading the silo using the intermediate cells, repair of all surface imperfections and the application of a waterproof elastic cover layer with an ability to bridge the surface cracks. A change of technology regarding the removal of the material was also recommended. These recommendations impacted the economics as well as the operating characteristics of the silo. For this reason Concordia Inc, the owner of the silo, required a re-evaluation of all previous inspection results and recommendations.

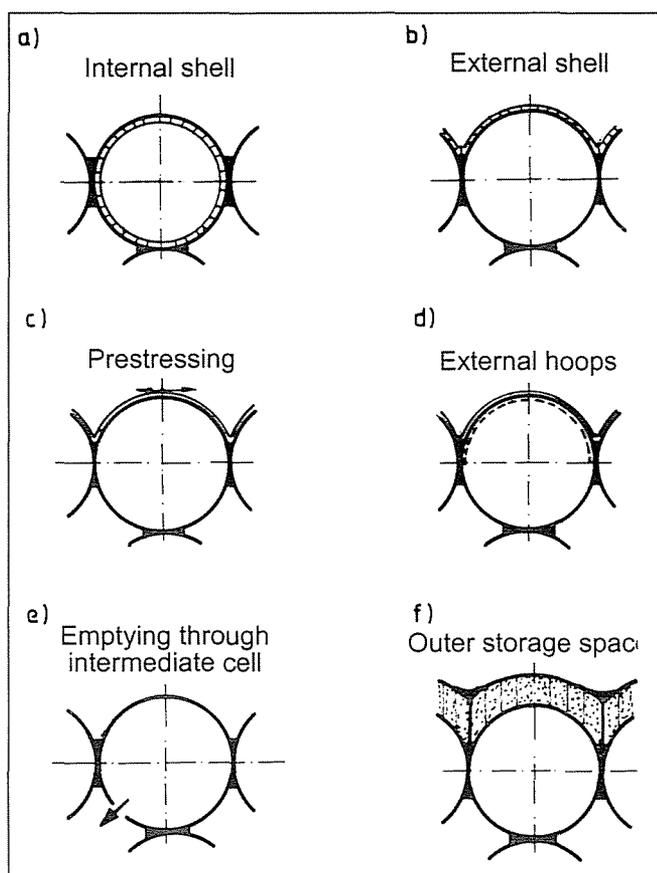
Fig. 4 Methods of strengthening

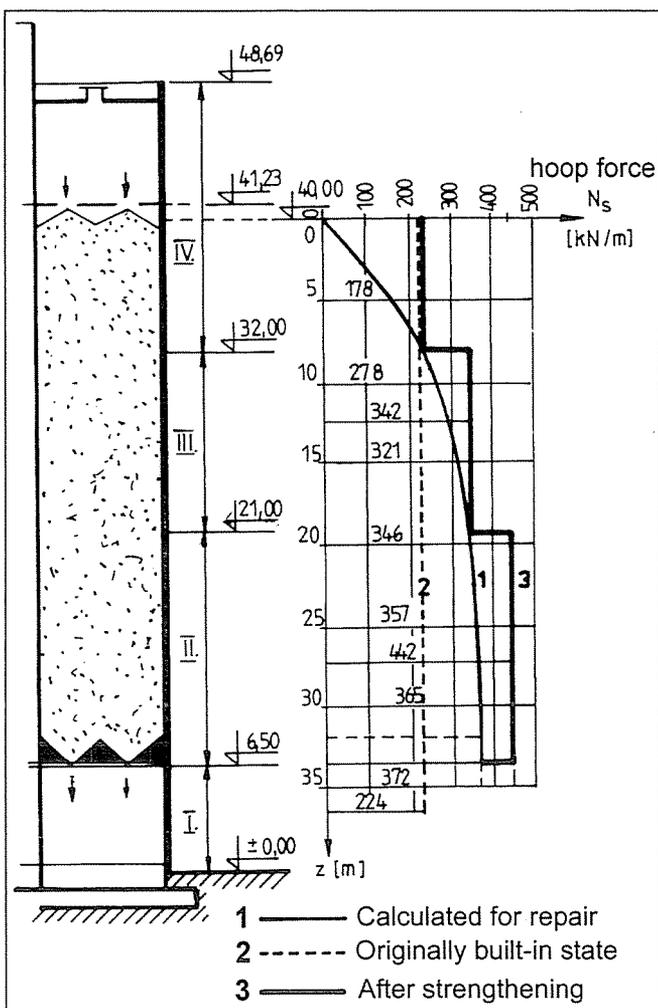
Fig. 5 Limit hoop-forces and ring-forces

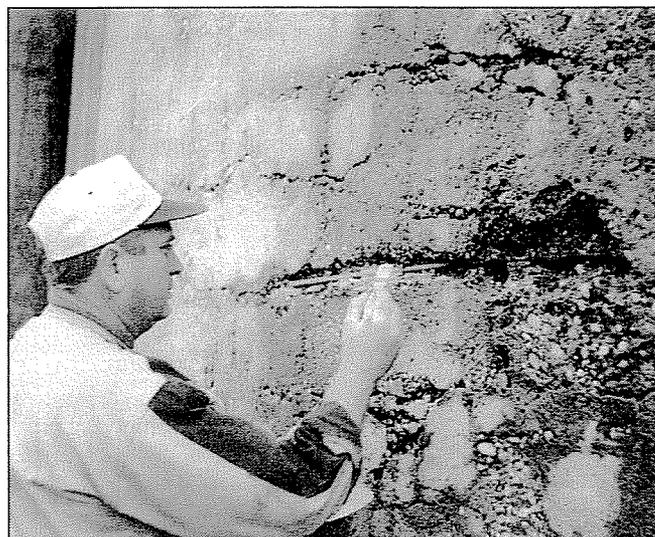
Photo 1 The wall of the silo after sand blasting and the corrosion protection of reinforcing bars

In some areas the removal of the original Elasztolen surface protection was difficult, in other areas it was easily removed. This confirmed that the Elasztolen surface protection was not applied uniformly in the silo surface. After completing the sandblasting an inspection of the cleaned-up surface revealed all the defects that were due to improper placement of the concrete at the time of construction. The cracked condition of the cell walls also became apparent. After sandblasting and chiselling off loose concrete all exposed reinforcement was covered with PROXAN Metallgrund brand corrosion protecting compound (*Photo 1*).

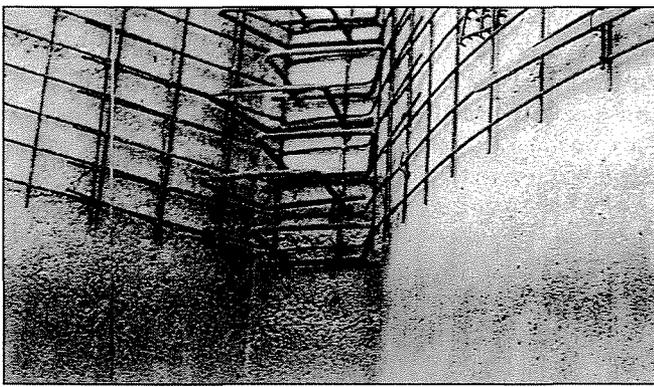
Photo 2 The anchorage and adjustment of wire mesh
