CONCRETE STRUCTURES

ANNUAL TECHNICAL JOURNAL

2000

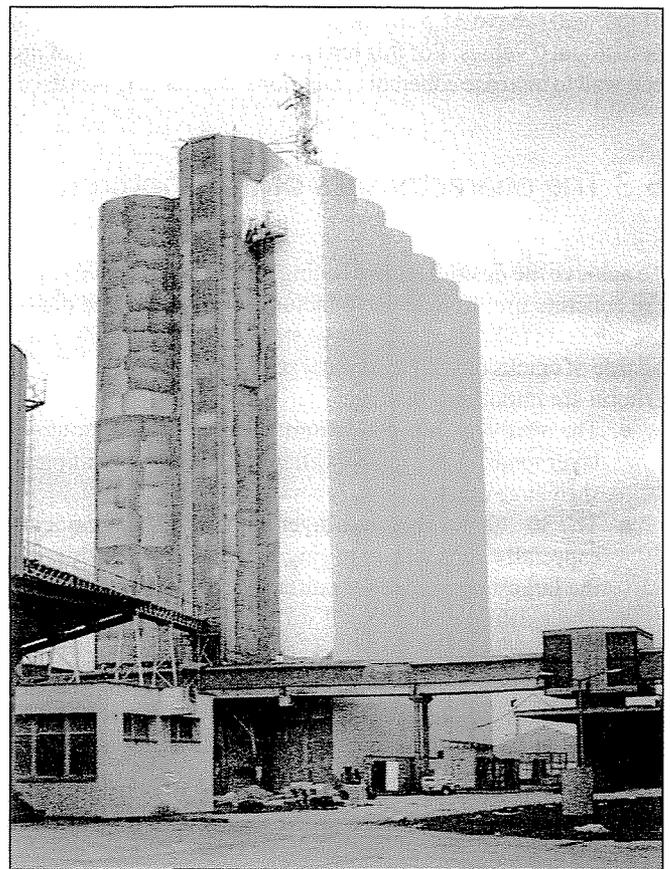
Photo 3 Base and cover painting of southern and eastern side

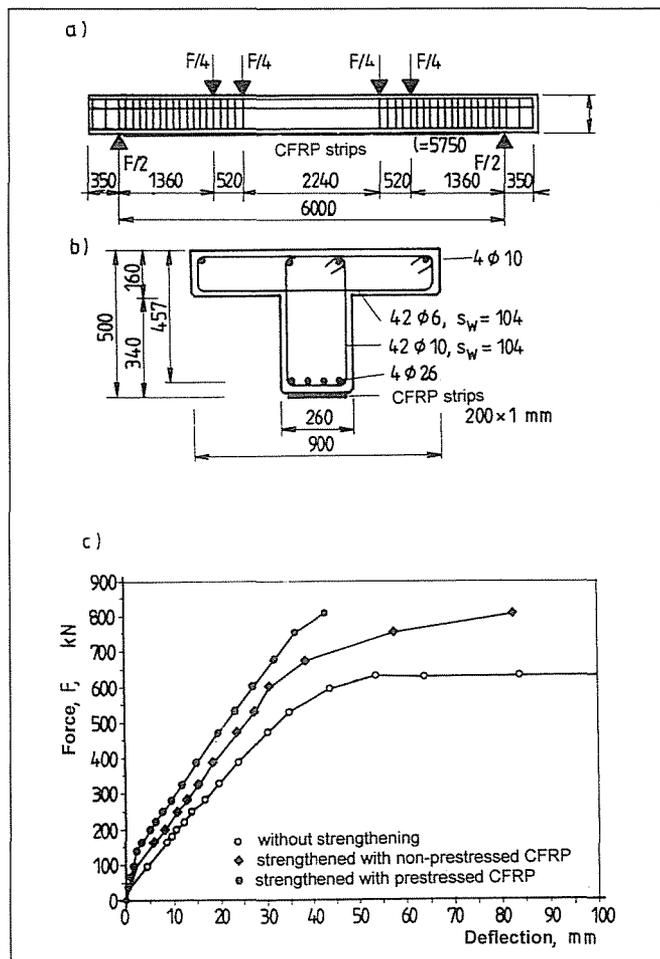
Fig. 1 Results of a comparative experimental study (Deuring, 1993)
a) Elevation
b) Cross-section
c) Load vs. deflection diagrams

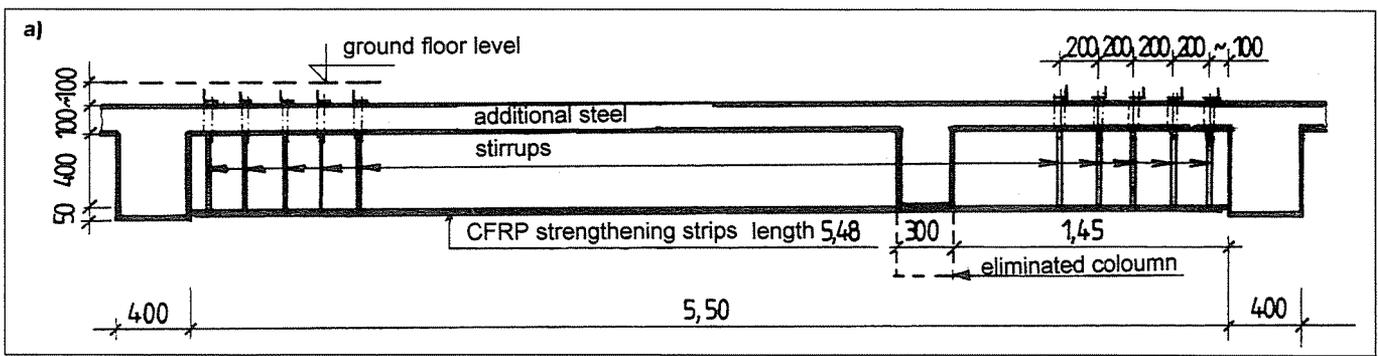
Fig. 3 Strengthening of the slab of a music school in Budapest, Erzsébet street 32. (Date: June 1996. Strengthening strips: Sika CarboDur S512-70 m Designer: Dr. György L. Balázs, Exec: Schöck and Co.)

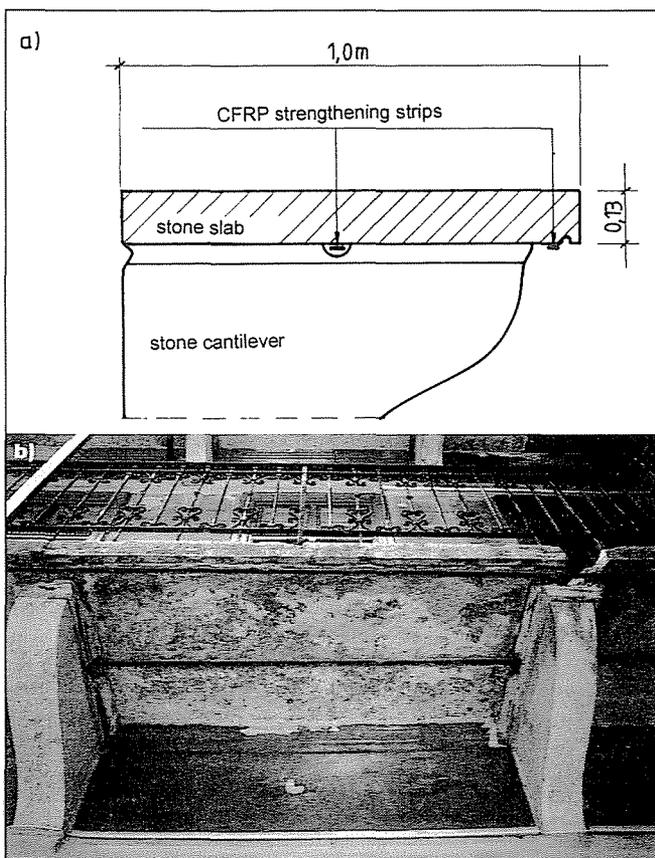
Fig. 5 Strengthening of natural stone balcony slabs in Budapest, Péterffy street 31. (Date: May 1997. Strengthening strips: Sika CarboDur s512-240 m. Designer: Dr. György L. Balázs. Exec: Schöck and Co.)
 a) Cross-section
 b) Photo after strengthening

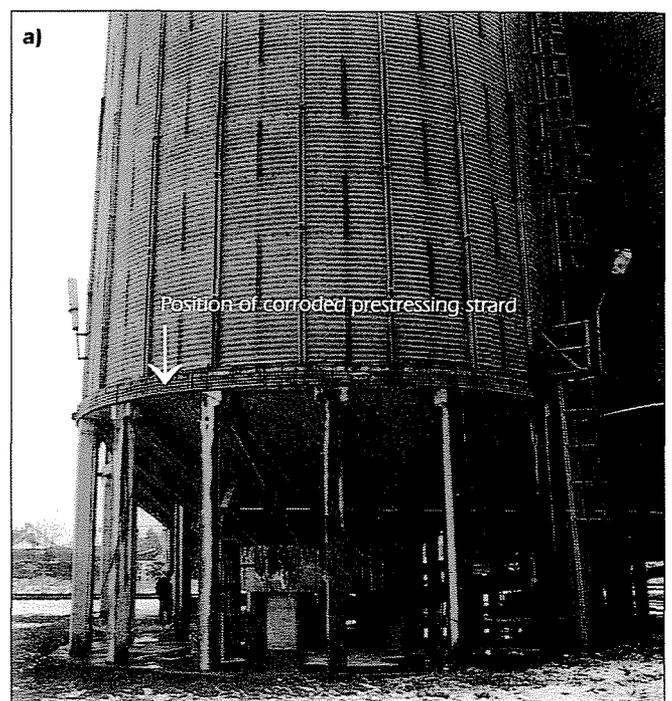
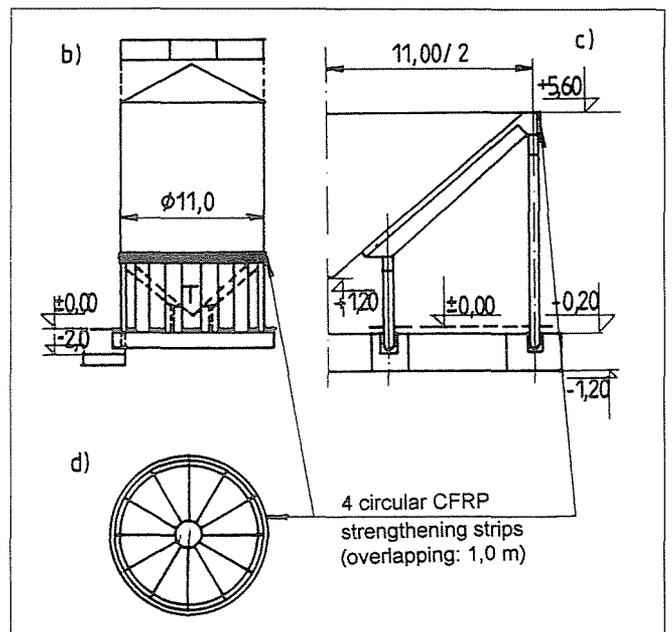
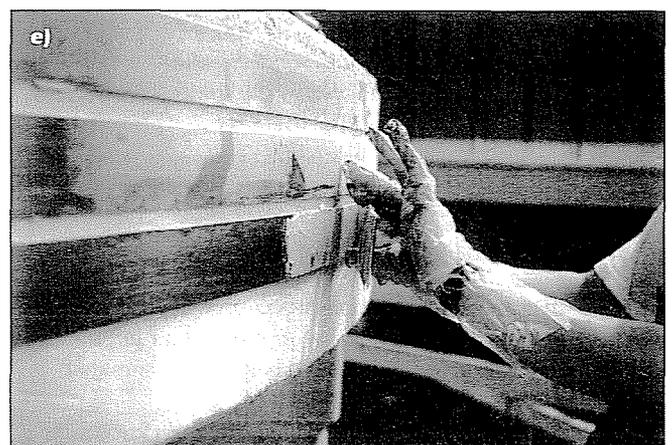
Fig. 6 Strengthening of a grain silo in Berettyóújfalú, Hungary, owing to the corrosion of circular prestressing tendons (Date: June 1997. Strengthening strips: Sika CarboDur S612-152 m. Designer: Dr. György L. Balázs. Exec: Isobau Rt.)
 a) Photo of the silo
 b) Elevation
 c) Vertical section
 d) Bottom view (indicating the segmental prefabricated elements)
 e) Application of strengthening strips

Several ways for strengthening were analysed and finally the decision was taken to glue 5 pieces of 28 m long Sika CarboDur strips. This operation was performed during night after the tram traffic had stopped (Fig. 7.b and d). Strengthening strips were of medium modulus equal to the modulus of steel.

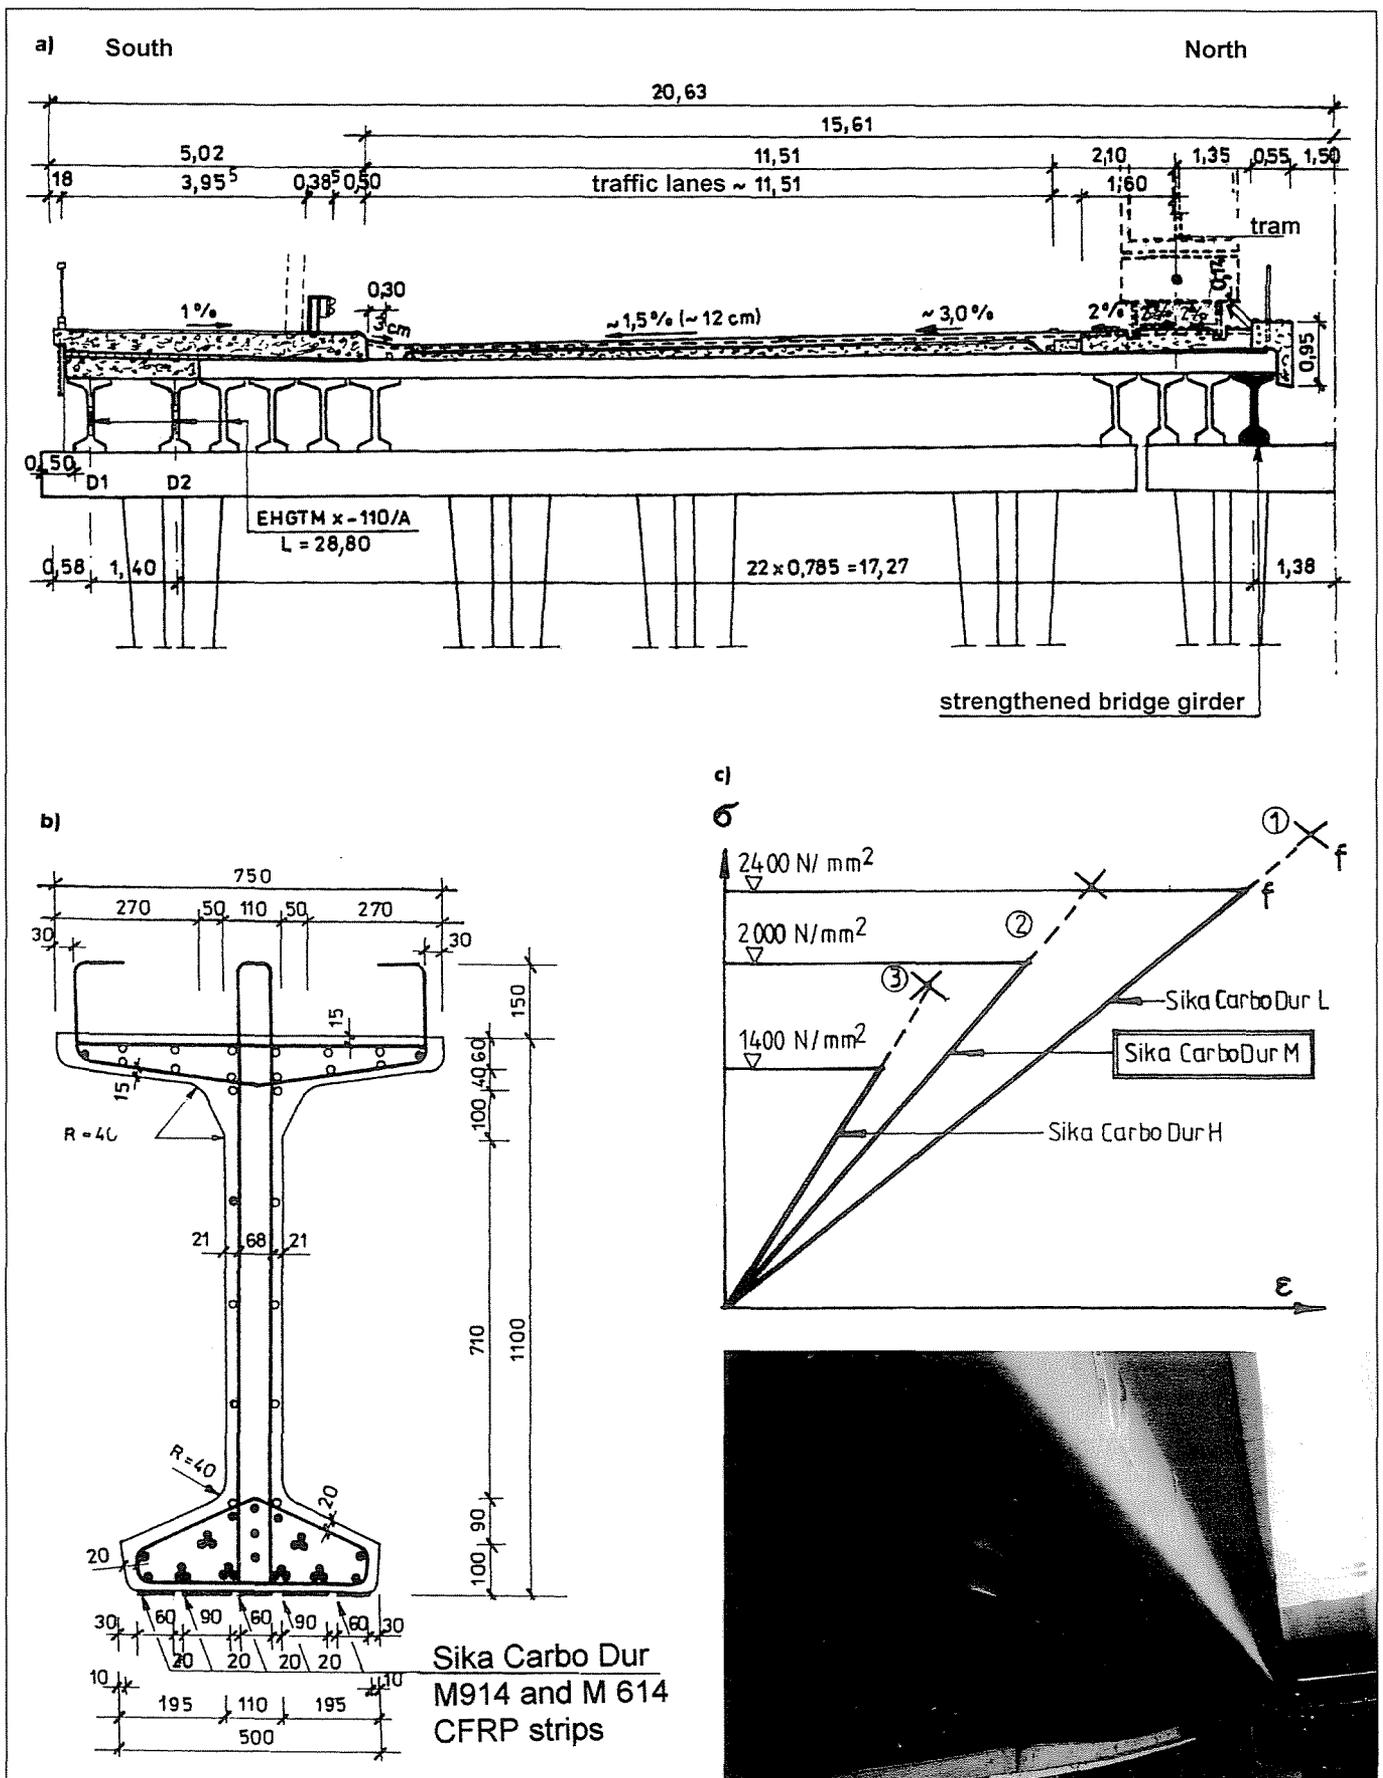
Fig. 7 Strengthening of a prefabricated prestressed pre-tensioned concrete bridge girder in Budapest, Petöfi bridge owing to the failure of some prestressing strands due to corrosion. (Date: Sept. 1997, Strengthening strips: Sika CarboDur H914-56 m and M614-84 m. Designer: Budapest University of Technology; Dr. György L. Balázs and Dr. György Farkas. Exec: Pannon Freyssinet Ltd.)

strengthening was already relatively high and therefore further failure of prestressing tendons is not excluded. Regular deflection and strain measurements are carried out for control.

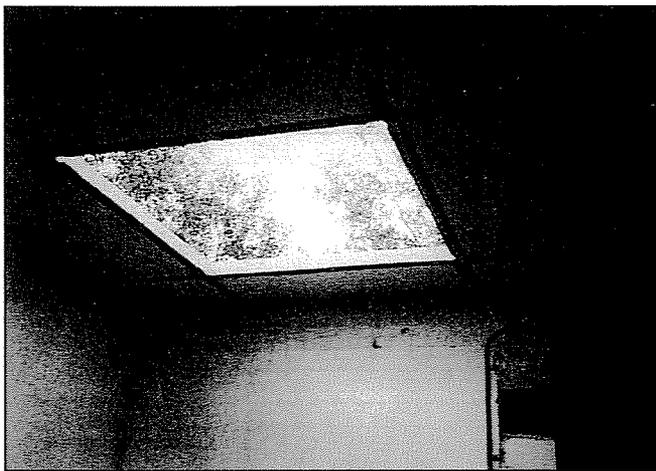
Fig. 8 Strengthening around an opening in a reinforced concrete slab at ZOLTEK Rt. in Nyergesújfalú, Hungary. (Date: Aug. 1998. Strengthening strips: Sika CarboDur M1214-25 m. Designer: Dr. Rita Kiss and Akos Sapkás. Exec: Fischer-bau Ltd.)

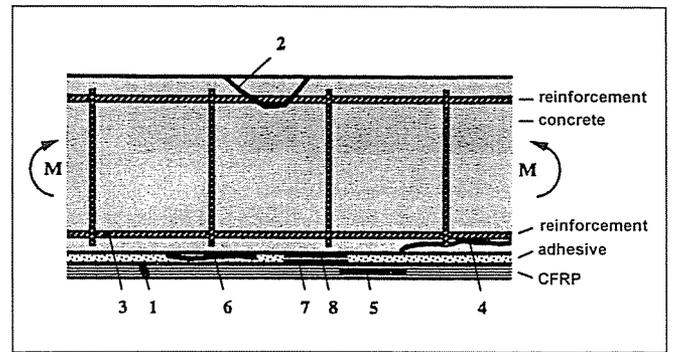
Fig. 10 Possible failure modes of a reinforced concrete member strengthened by carbon fibres (Deuring, 1993)

- Failure of strengthening strips or embedded reinforcing bars (or both).
- Crushing of compressed concrete.
- Debonding of glued surfaces.
- Cracking within the glue layer.
- Peeling-off in the anchorage zone.

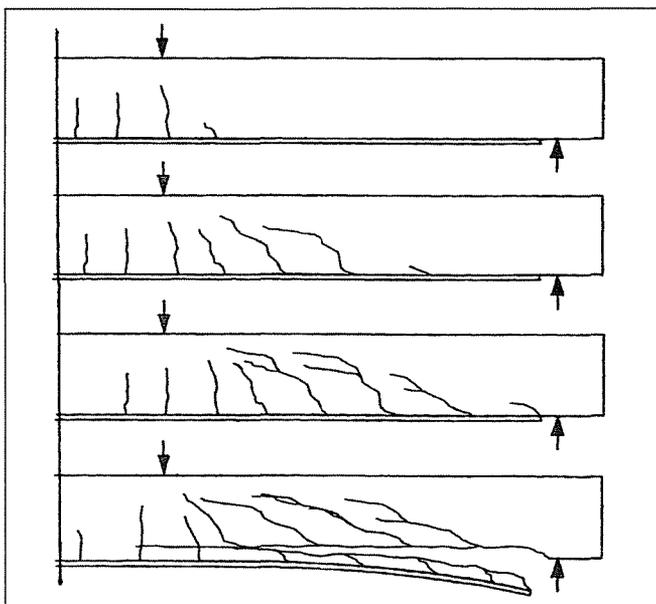
Fig. 11 Anchorage failure (peeling off) (Hollaway and Leeming, 1999)
